Report to DOT/PHMSA Steering Committee on Collaborative Demonstration of Guided Wave Ultrasonics

**Report to DOT/PHMSA Steering Committee on
Collaborative Demonstration of Guided Wave Ultrasonics
NYSEARCH**

Controlled Tests & Data Analyses

By
Daphne D'Zurko
Executive Director, NYSEARCH
Version for Public Release
April 2007

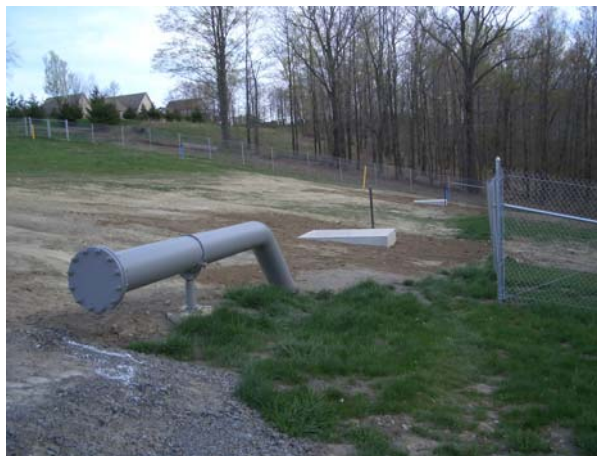
Figure 1. Access points for 12" Cased Pipe

It is worthy of note that two of the three 100' cased pipe sections are above-ground sections. The third is a 12" carrier pipe in a 16" casing in an underground network. In the 12" carrier pipe case, the vendors were notified that the guided wave transducer belt could be applied above-ground near the access point but between two 45-degree bends OR at the same level as the overall cased pipe section because of underground excavation vaults that had been constructed on both the North and South ends of the 12" cased pipe for the purpose of integrity inspection tests. Figure 1 illustrated both access points; in the foreground is the above-ground access point to the 12" pipe and in the background is one of the two underground vaults for direct straight-pipe access.
